# 2 Allegheny Center

Insulated Metal Panel Condition Assessment | Pittsburgh, PA

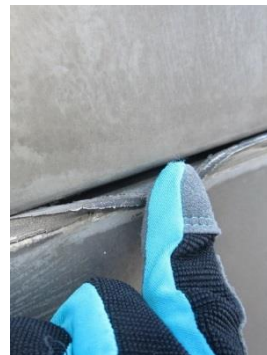
The outboard aluminum facer of a spandrel panel on the west elevation delaminated from the insulation core and fell from the 11th floor of the building. Prior to this most recent failure, five other spandrel panels had fallen from the 11th floor on the west elevation. As such, the owner, Faros Properties, requested WJE determine the cause(s) of the spandrel panel failures and to assess the condition of other metal spandrel panels, so that necessary repairs can be incorporated to mitigate the risk of falling debris hazards due to this condition.

WJE found three panels that were in danger of falling and were immediately repaired. It was determined that the delamination of the facer is likely caused by the deterioration of the adhesive due to moisture. Full panel failure is caused by the disengagement of the snap-on aluminum clip that engages the window frame above and below the spandrels.

To limit the introduction of water into the panels, new panel-to-panel sealant was recommended. Additionally, where the snap-on trim is loose or missing, a new anchorage detail was recommended to prevent future failure.

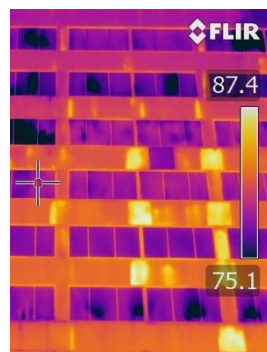
WJE's investigation included a document review of original architectural and structural drawings as well as vintage product literature as they pertain to the metal spandrel panels, an infrared thermography survey, and a visual condition survey that included a close range visual survey of the metal spandrel panels. In order to perform the close range assessment, WJE's Difficult Access Team was called upon to use rappelling, climbing, and rope techniques to perform the investigation. At each rope drop location, WJE assessed the condition of the sealant, exposed insulation, spandrel panels and anchorage, and performed limited testing to determine if thermal anomalies relate to delaminated aluminum facers.
