JUNE 2017 V. 39 No. 6

# ci Concrete international

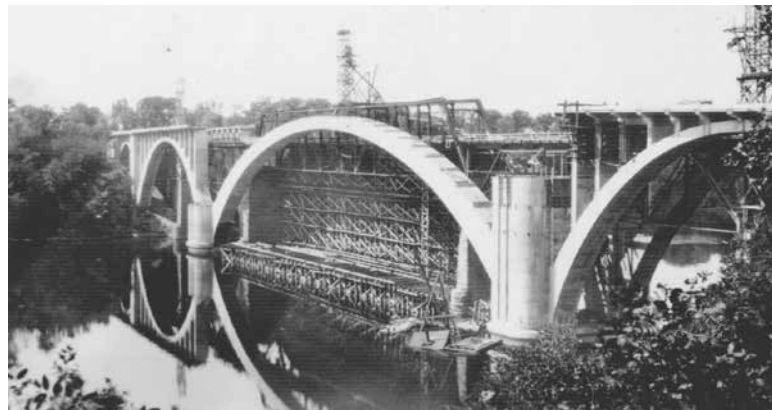
Fig. 1: Franklin Avenue Bridge during construction, circa 1923 (from Reference 1)

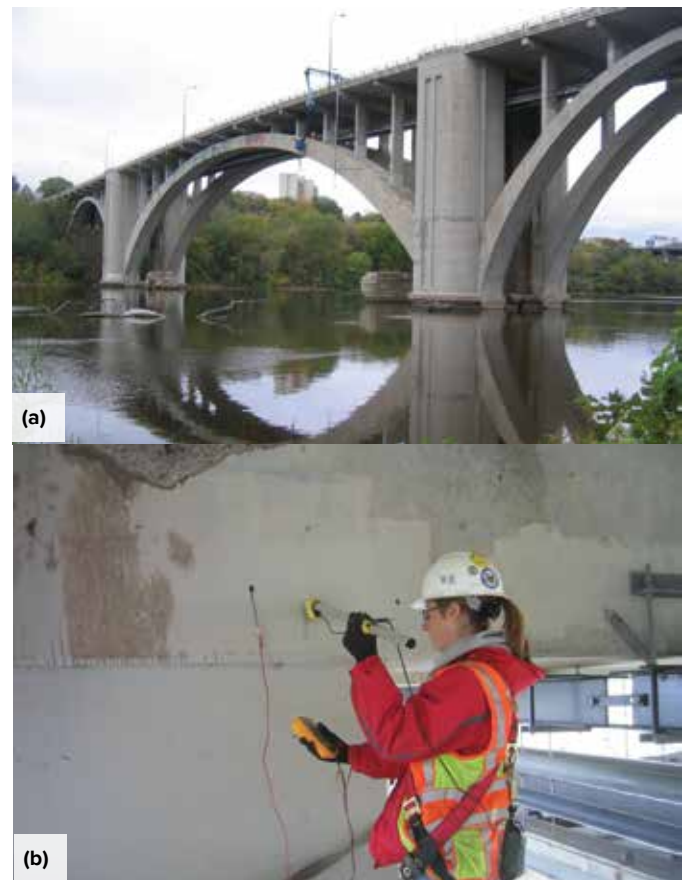
**Fig. 2: Bridge investigation activities in 2007: (a) inspection, field testing, and material sample collection; and (b) half-cell corrosion potential measurements**

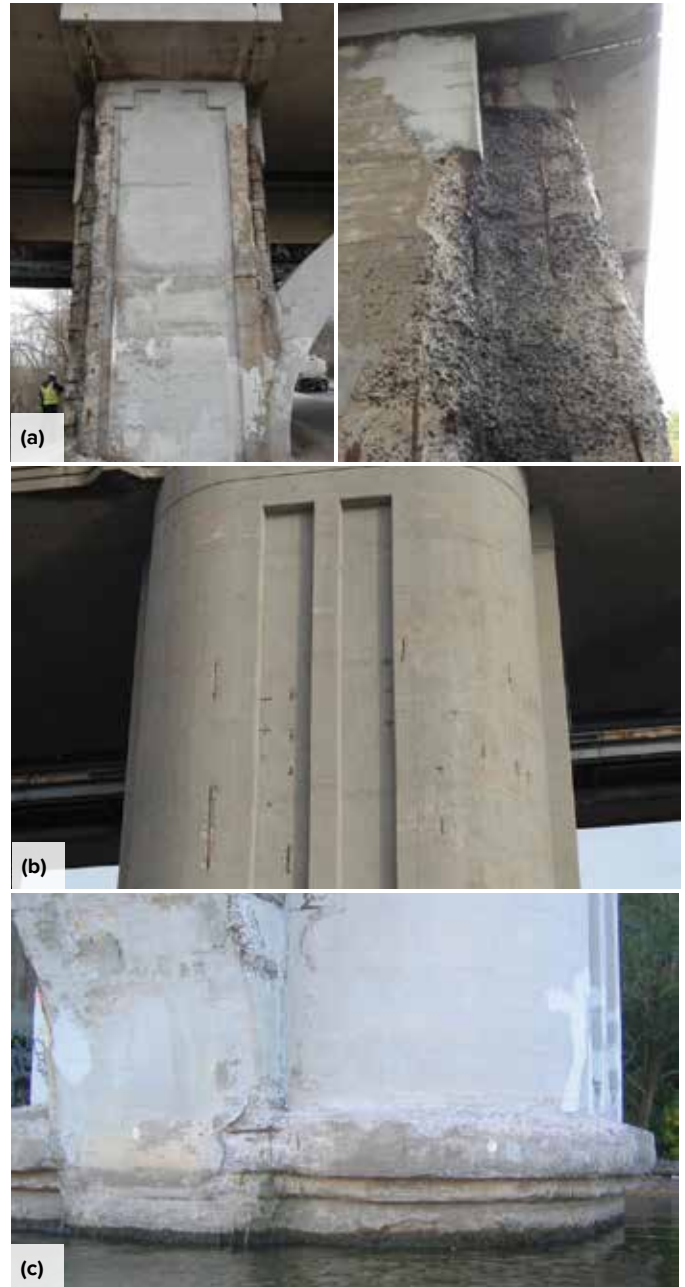
**Fig. 3: Examples of observed concrete deterioration: (a) severe spalling of river bank pier located below deck expansion joints; (b) isolated corrosion-induced spalls at shallow cover conditions on river pier; and (c) severe freezing-and-thawing distress near waterline on river pier**

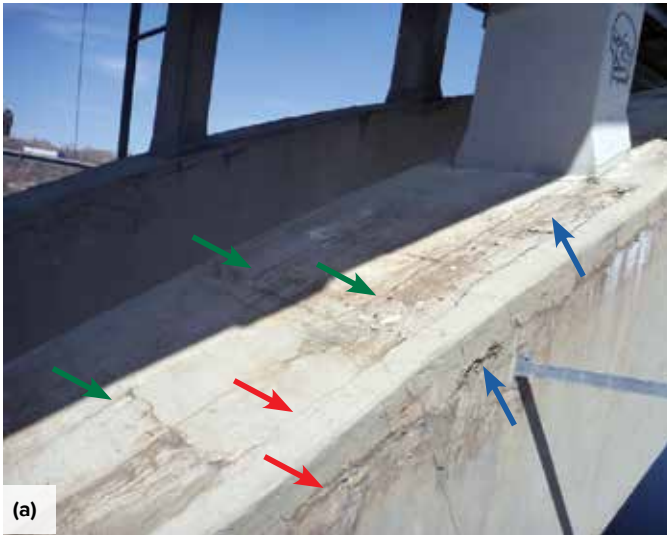
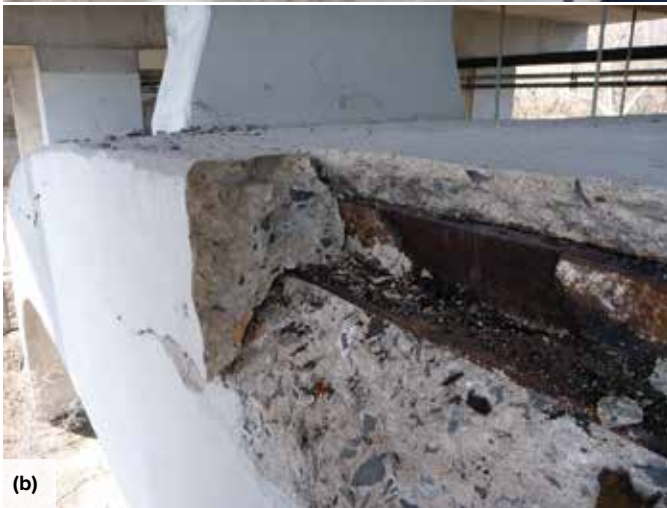
**Fig. 4: Examples of arch rib distress conditions: (a) red arrows indicate cracking and delamination at corners, green arrows indicate cracking along interior lines of steel truss reinforcement, and blue arrows indicate freezing-and-thawing damage; and (b) loss of corner concrete caused by corrosion of steel angle**

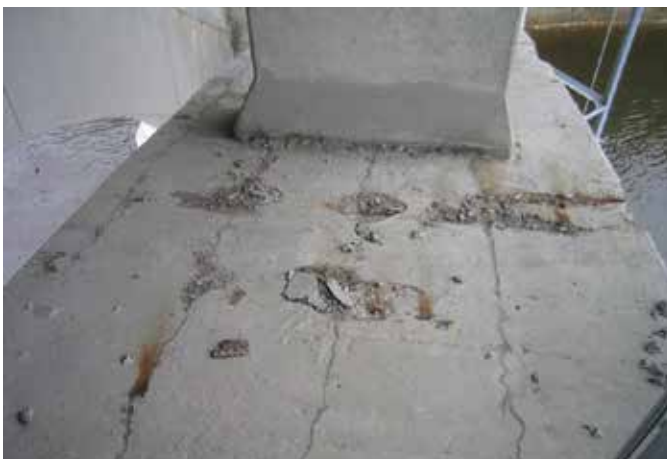
**Fig. 5: Longitudinal cracking along interior lines of steel truss reinforcement**

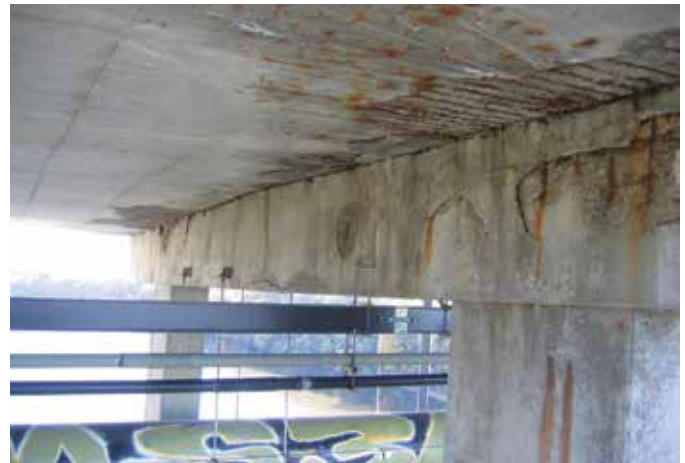
**Fig. 6: Reinforcing steel corrosion and spalling due to leakage of expansion joint over cap beam**

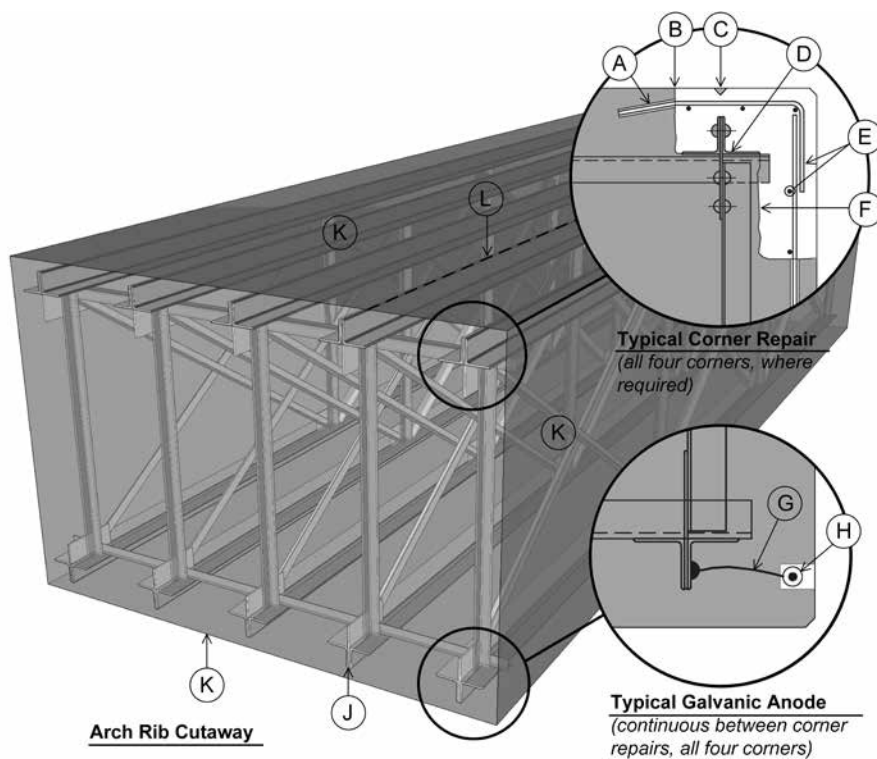
**Fig. 7:** Cutaway through arch rib showing Melan truss reinforcement and typical concrete repairs: (A) epoxy-grouted dowels for anchorage; (B) saw cuts at repair perimeter; (C) tooled joint with sealant; (D) clean and coat existing steel; (E) crack control reinforcement; (F) properly prepared sound concrete substrate; (G) intermittent slots and wire connections to existing steel; (H) continuous zinc anode in sawcut slot; (J) Melan truss reinforcement; (K) typical surface repairs (where required); (L) rout and seal crack repairs (where required)

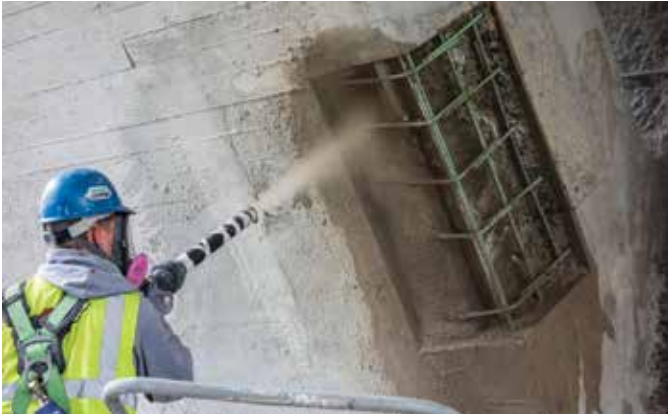
**Fig. 8: Dry-method shotcrete repair on arch rib corner**

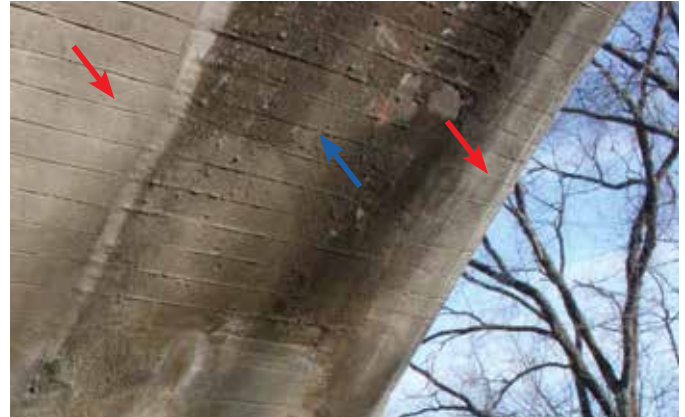
**Fig. 9: Form-board finish on new repairs (red arrows) adjacent to original surface texture (blue arrow)**

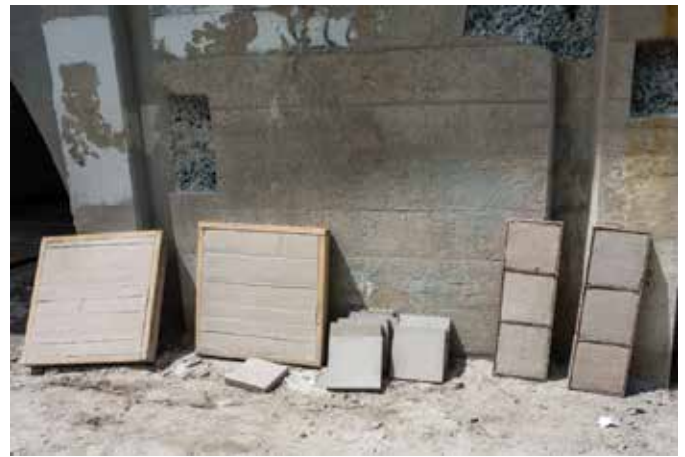
**Fig. 10: Shop samples showing range of colors and field samples showing form-board finish**

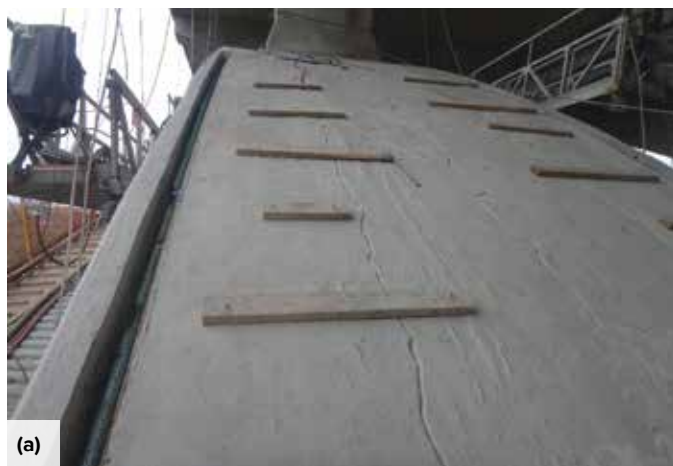
According to NPS Preservation Brief 15,<sup>4</sup> film-forming coatings are often inappropriate for use on a historic structure, unless the structure was coated historically. In the case of the Franklin Avenue Bridge, previous surface treatments had been applied, including cementitious wash, cementitious parge, and paint. Furthermore, absent bulk protection of the concrete surface from moisture, future deterioration, and loss of historic fabric would be likely. After thorough discussions between historians and technical experts, it was agreed that a high-performance, film-forming, water-resistant coating would be applied to all historic concrete surfaces. Relatively

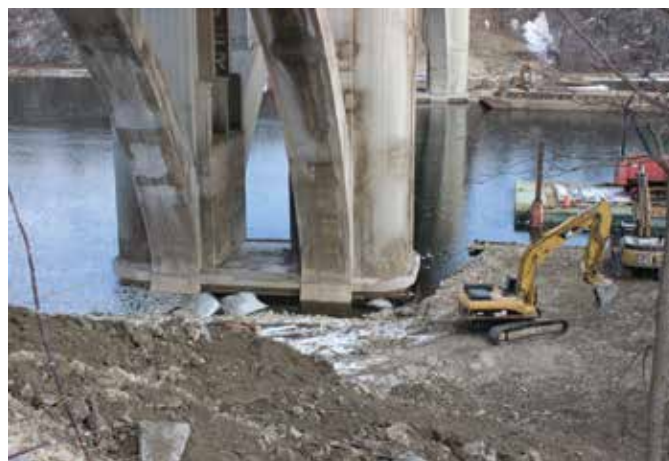
**Fig. 12: Completed concrete jacket around base of river pier (after removal of coffer dam)**

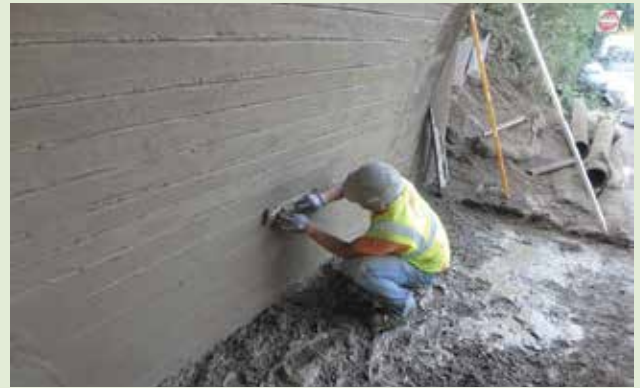
Finishing form-board lines in wet shotcrete
